Intensive post-event campaign (IPEC) Slovenia November 2007

- The IPEC procedure
- The results
- First interpretations

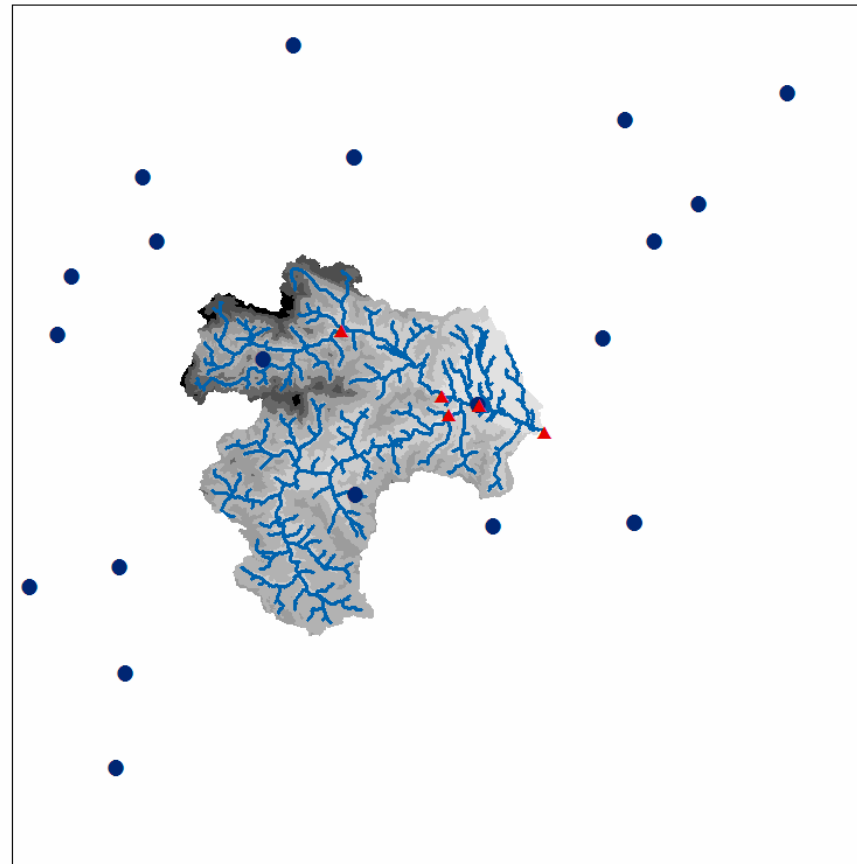
The Selscica watershed upstream Zelesniki. Some data collected on the Cerknica watershed upstream Cerkno.

- ▲ streamgauges
- raingauges

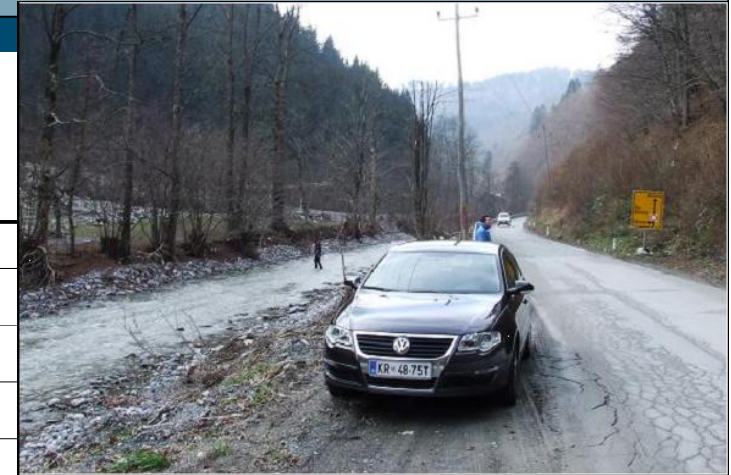
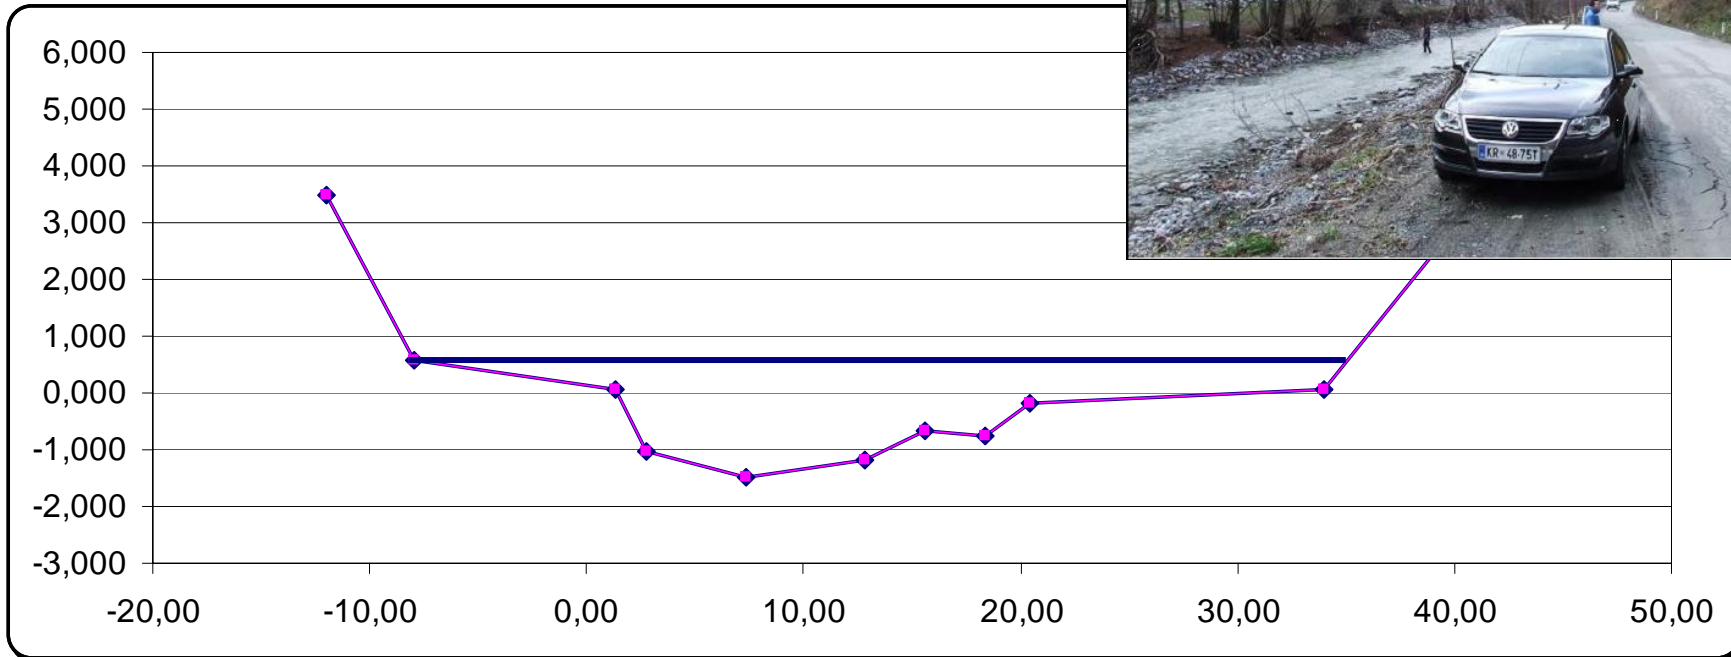
Cross-section surveys:

Cross-sections :

River bed : 35 m²

Right bank : 4 m²

Left bank : 12 m²

Slope 1.2 %

Velocities river bed : 3.5 m/s

Velocity right bank : 0.3 m/s

Velocity left bank : 0.5 m/s

Estimated discharge : 140 m³/s

Minimum guess : 110 m³/s

Maximum guess : 165 m³/s

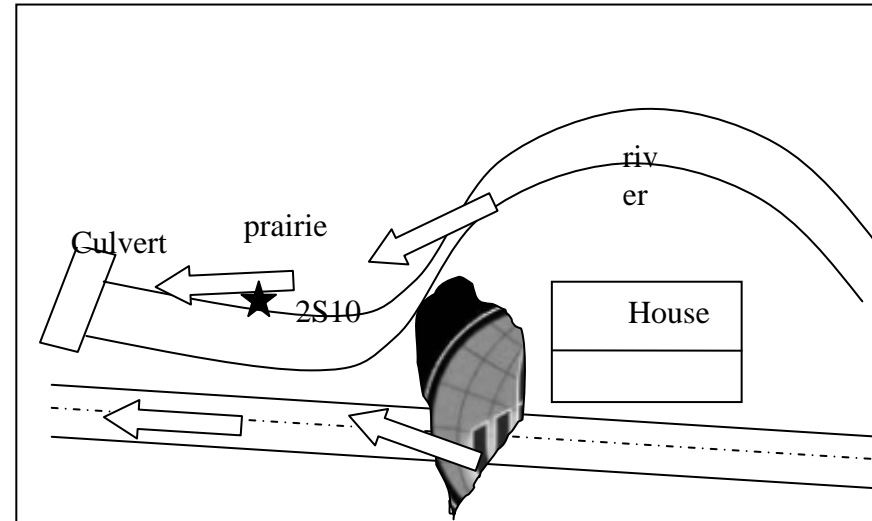
Description of the site: Isolated house, located 200 meters upstream section 2S10 on the left hand side of the river, just upstream the confluence with a small tributary.

The intense rainfall started at 11h00, the maximum level has been reached between 12h00 and 13h00. The maximum level was reached within 30 minutes. The water retreated also rapidly, within one hour. There has only been one peak. A debris flow occurred on the small tributary simultaneously to the flood and covered the road. It diverted one part of the flow from the main stream which has flown on the prairie on the right bank of the river and returned to the river at the level of the culvert situated a few hundred meters downstream.

The debris flow stopped on the road and the corresponding water flowed on the road downstream.

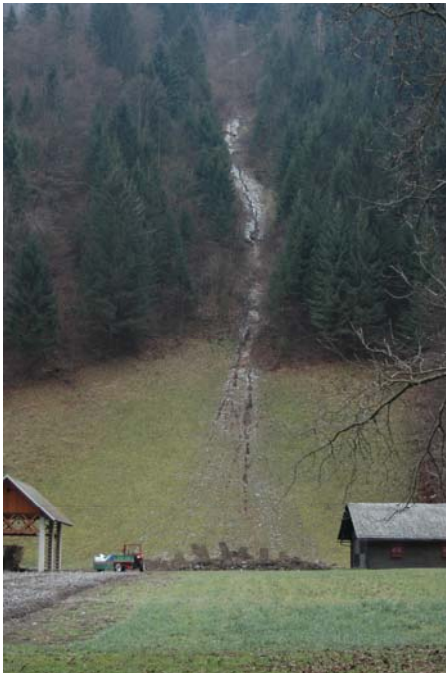
Erosion rills

**A large variety of erosion processes
linked to faults and subsurface flows**

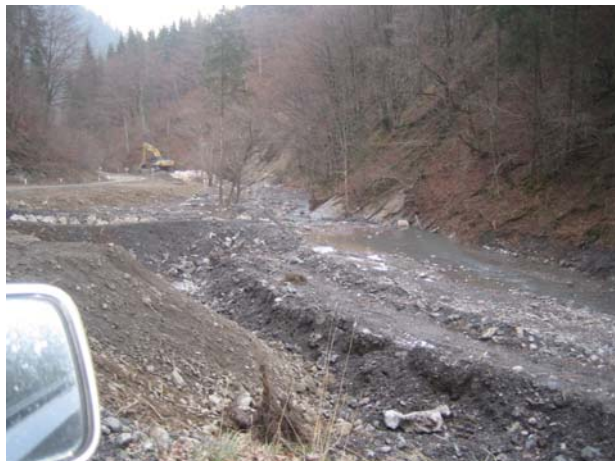
Sediment deposition area

Succession of eroded and filled reaches along the main river channels. Few amount of sediments transferred downstream.

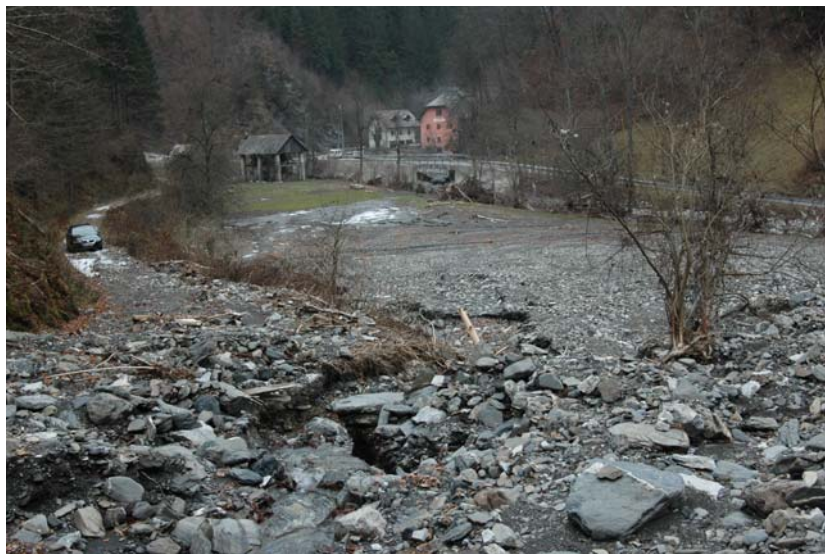
**Debris flow fan
in Selscica valley**

Specific study of one debris flow (UPC).

No major landslide, mobilization of the material stored in the thalweg.

Continuous and progressive process.

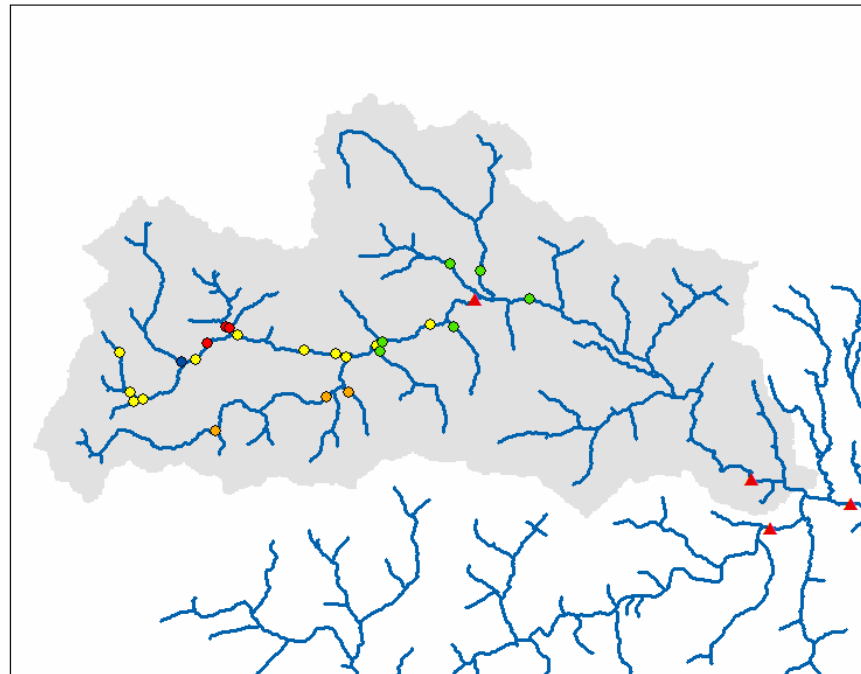
Peak discharges

discharge estimations

Spec.discharge

- <1
- 1-3
- 3-5
- 5-10
- >10

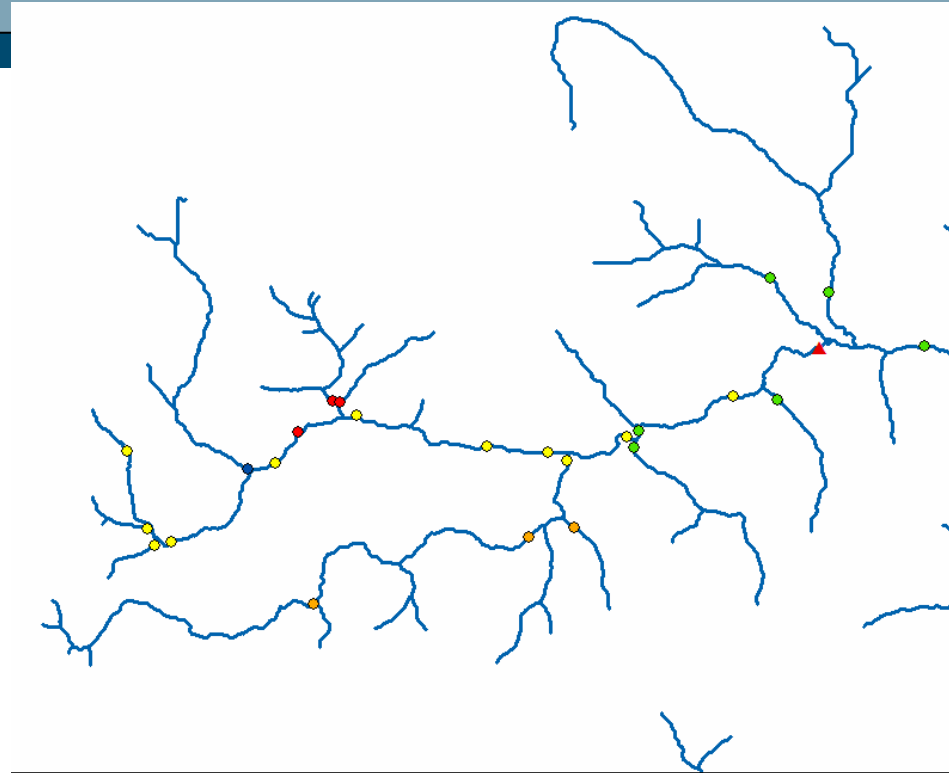
Peak discharges

- Coherent values
- Validation of the stream gages first evaluations
- Some surprises
- Limited runoff rates

discharge estimations

Spec. discharge

- <1
- 1-3
- 3-5
- 5-10
- >10

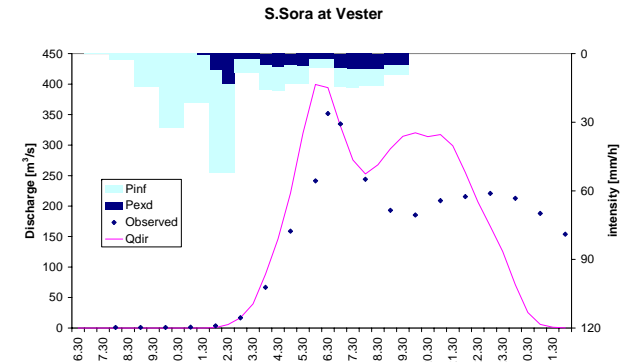
Rainfall-runoff dynamics

- Moderate instantaneous runoff rates (<20%)
- Important role of infiltration and subsurface flow with extremely rapid drainage dynamics (a few days)
- Flood wave attenuation and slowing in Zelezniki and downstream
